Mounting a 720 kB disk drive into a Philips VG 8230

Original by: Bas Kornalijslijper

Translated by: Bart Hamer

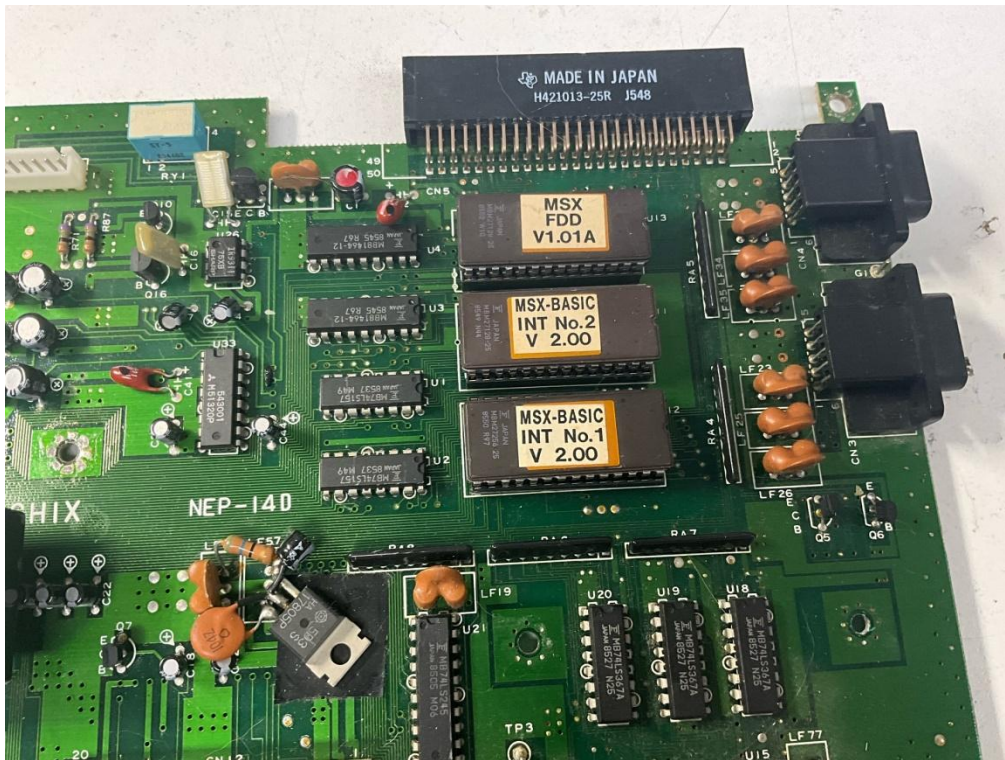
The original disk ROM, U13, in the IC socket.

- Remove U13, the disk-ROM (placed in an IC socket).
- Insert the new disk-ROM into the empty socket of U13. This new system-ROM is required for double-sided operation.
- At the bottom side of the main board two print tracks need to be cut. These print tracks are connected to pin 8 and 9 of the connector (located at the disk drive connector side of the main board).
- At the bottom side of the main board two extra connections need to be added (located at the disk drive connector side of the main board).

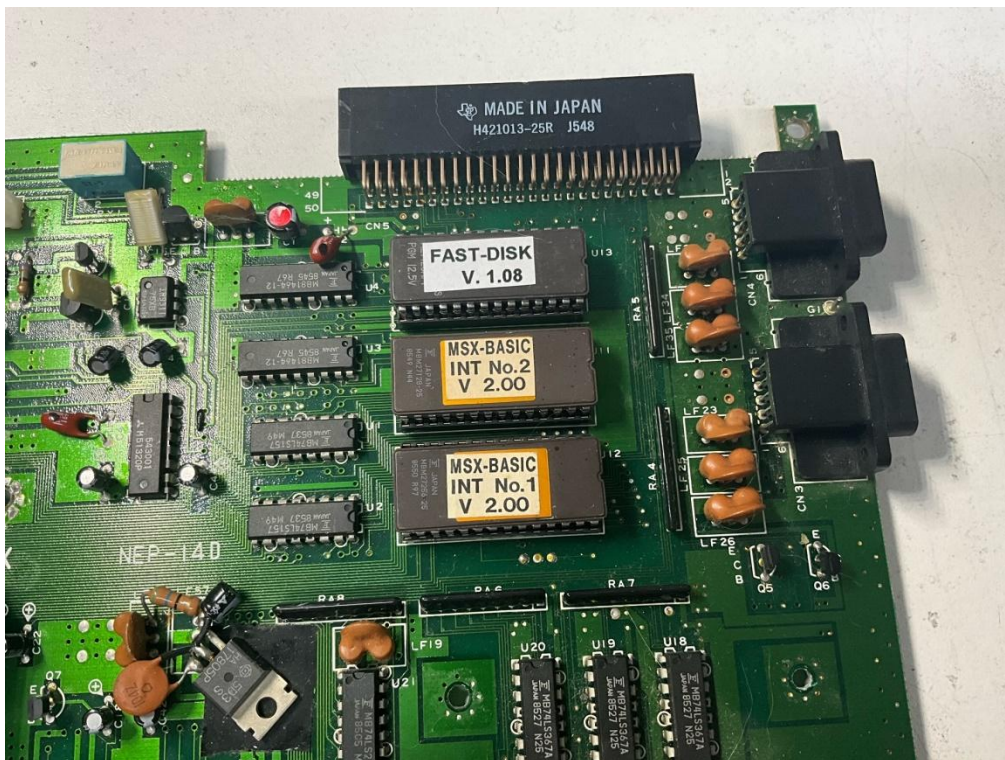
The new disk ROM is placed in the IC socket of U13.

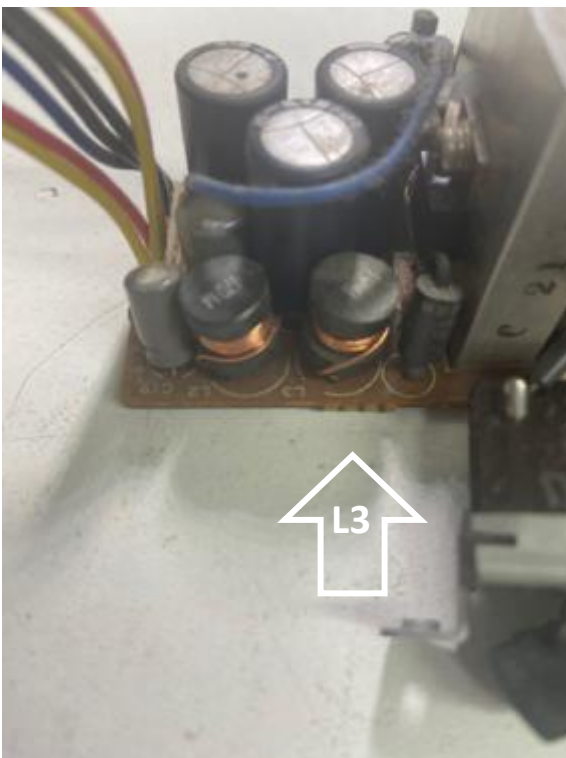
The original disk drive of the Philips VG 8230 uses a 14-pin connector. Also, it requires both +12V DC and +5V DC. The replacement disk drive has a 34-pin connection and requires only +5V DC. Because the new disk drive requires more power from the +5V DC powerline distortions can be seen on the screen during disk activity. This problem can be solved by replacing coil L3 on the power supply PCB with a wire.

The power supply's PCB before the adjustment.

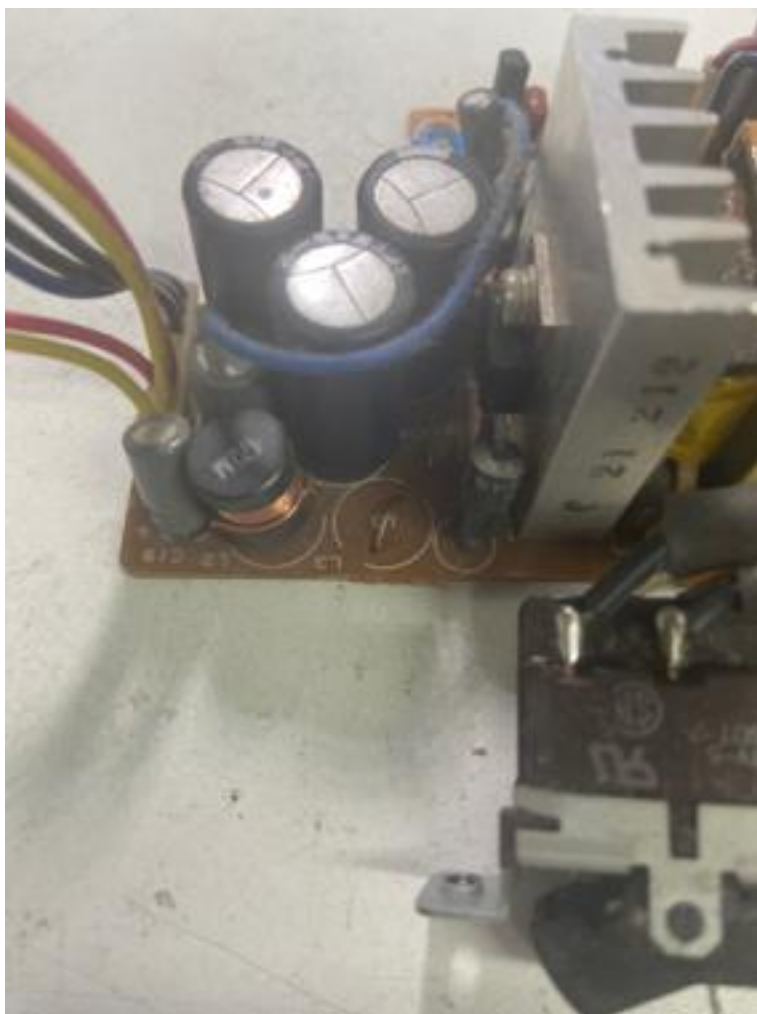
The power supply's PCB after replacing L3 with a wire.

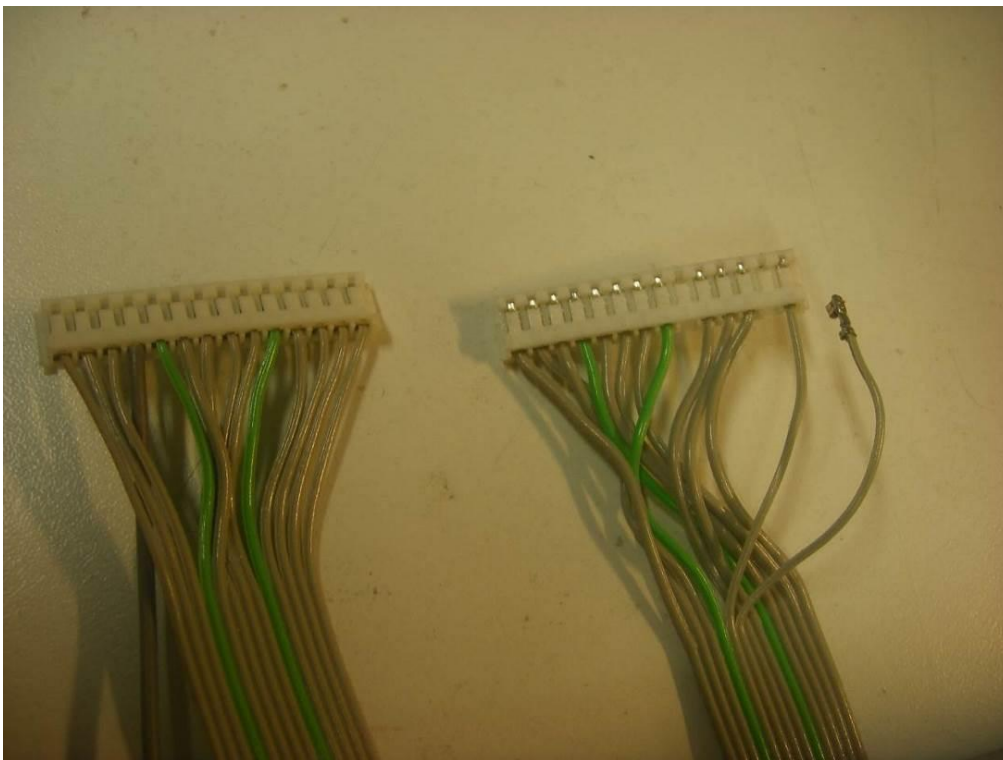
Left: cable with original wiring.

Right: the rewired cable.

The existing cable can be reused, but it needs to be rewired. This is done by putting several wires to different positions on the 14-pin connector at the disk drive side of the cable. It can then be plugged into the 34-pin disk drive connector. The 'thicker' gray wire (pin 11) is a ground wire, it is connected next to the red wire in the 4-pin power connector of the disk drive.

Main board side		Disk drive side
1	-----	3
2	-----	8
3	-----	9
4	-----	10
5	-----	11
6	-----	4
7	-----	5
8	-----	Connected right next the 14-pin connector at position '15'.
9	-----	1
10	-----	7
11	-----	Connected to the ground of the power supply of the disk drive.
12	-----	12
13	-----	13
14	-----	14

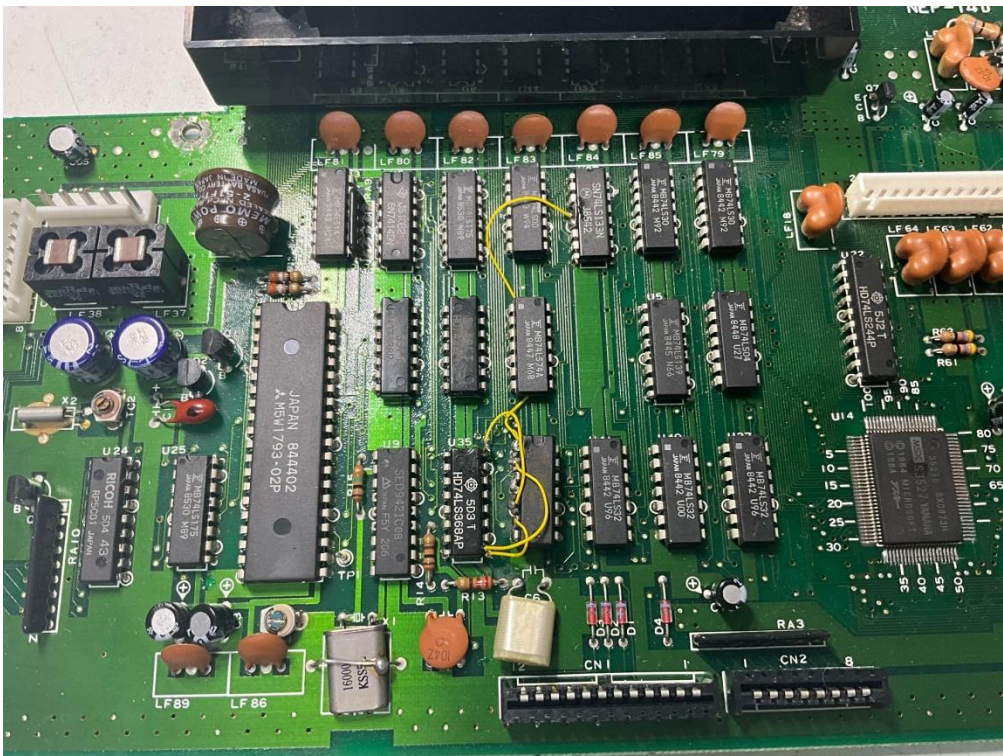
After the new disk ROM and double-sided disk drive are installed, it is possible to use 720 KB diskettes. Booting with MSX-DOS will not yet be possible. This is because the motherboard of the VG 8230 has a hardware error, which prevents MSX-DOS from booting correctly. This was one of the reasons why Philips introduced the VG 8235/00 shortly after the release of the VG 8230. The problem with the VG 8230 motherboard can be solved with a number of changes:

The wiring at the top of the main PCB.

- Cut pin 4 from U27 (74LS30).
- Cut pin 9 from U35 (74LS368).
- Solder the 74LS86 with the remaining pins to U45 (74LS32).
- Make a connection between U27 (74LS30) pin 4 and pin 5.
- Make a connection between the 74LS86 pin 1 and the print spot of U27 (74LS30) pin 4.
- Make a connection between the 74LS86 pin 2 and U35 (74LS368) pin 9.
- Make a connection between the 74LS86 pin 3 and pin 4.
- Make a connection between the 74LS86 pin 5 and U35 (74LS368) pin 16.
- Make a connection between the 74LS86 pin 6 and the print spot of U35 (74LS368) pin 9.
