Repairing the disk drive of a Philips NMS 8245

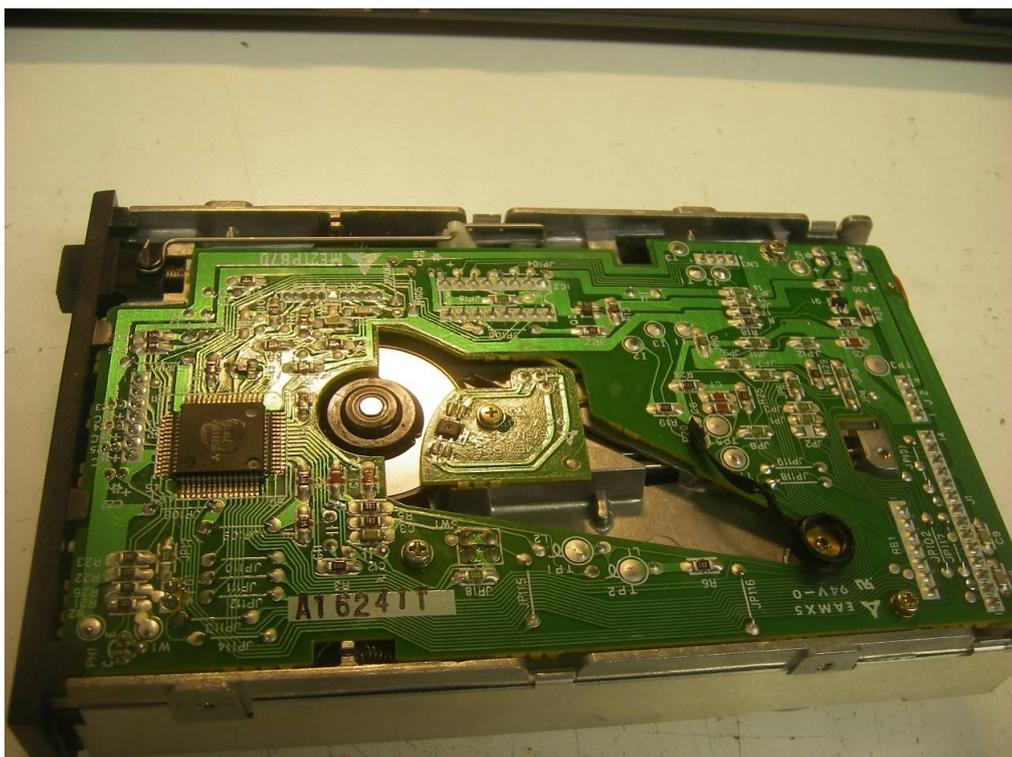
Bottom of the disk drive with a dried out belt.

- Remove the disk drive from the computer and remove the bottom plate.
- Remove the cover.
- Remove the front panel.
- Unscrew the large PCB.
- Unscrew the small PCB, paying attention to its orientation. There is a slot in it.
- Disconnect the motor connector and set the board aside.
- Remove all remnants of the old belt (degrease if necessary).
- Insert the new belt.
- Reassemble everything (be careful when replacing the small PCB with the slot).

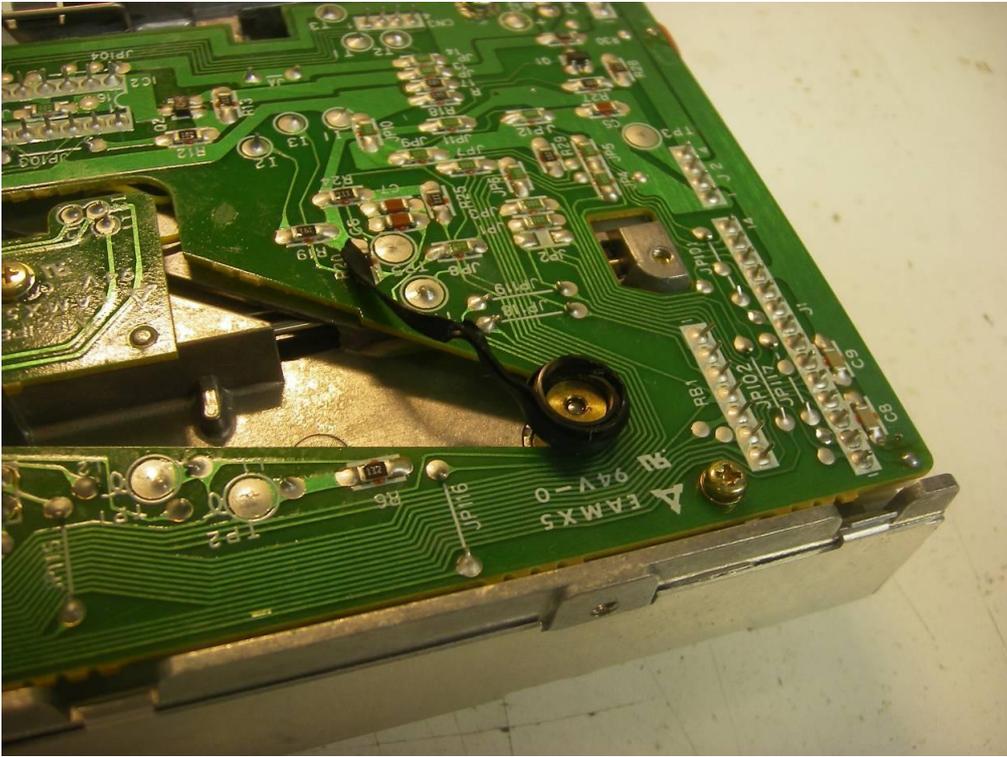
Detail photo of the remains of the old belt.

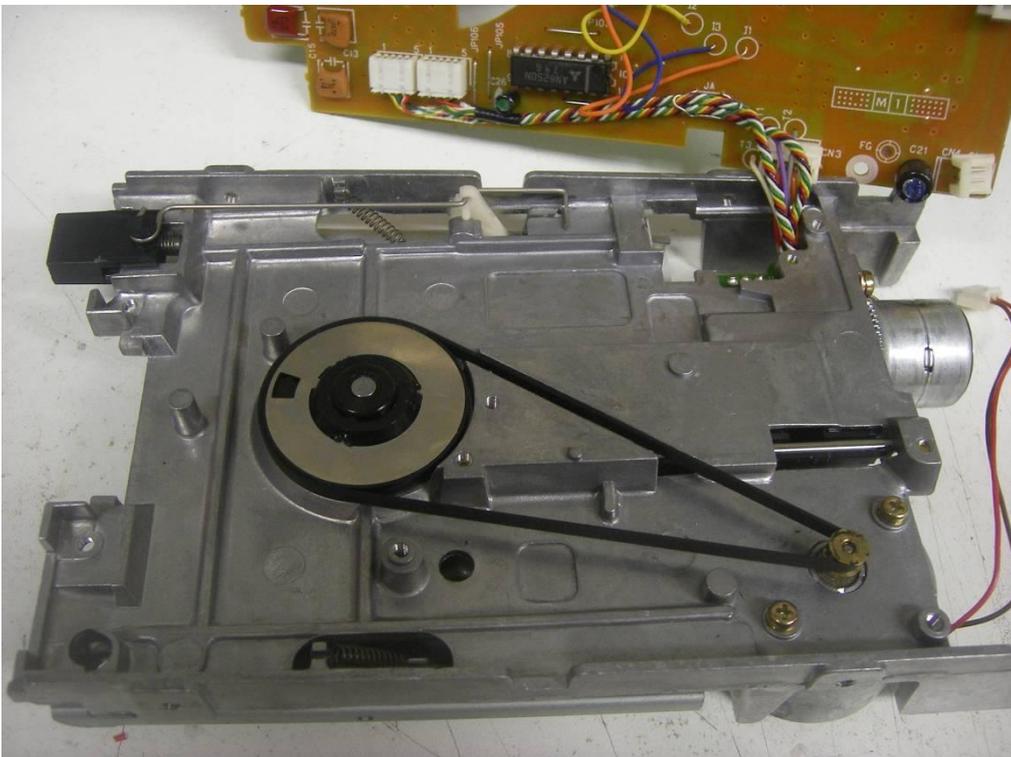
The disk drive with the PCB removed and fitted with a new belt.

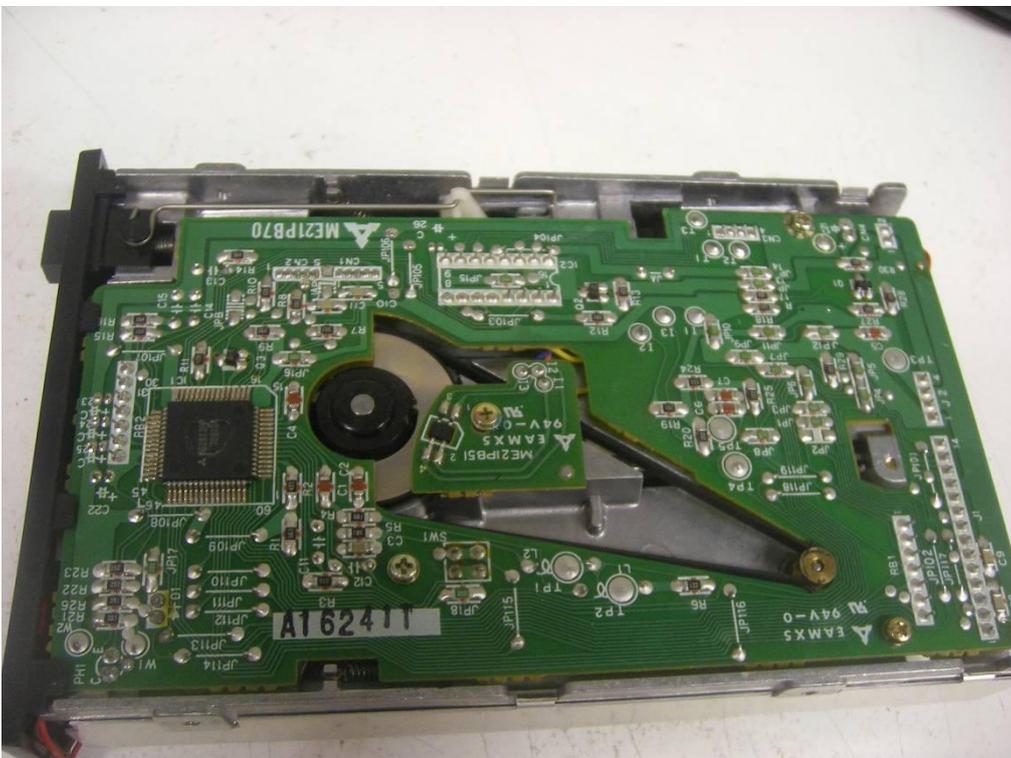
The reassembled disk drive with a new belt.
